YAMAHA SERVICE NEWS

MAIL ADDRESS: BOX 54540, LOS ANGELES, CALIFORNIA AREA CODE: 213 · OVERLAND 5-5135 Service News #178

YL-2 OVERHEATING PROBLEM

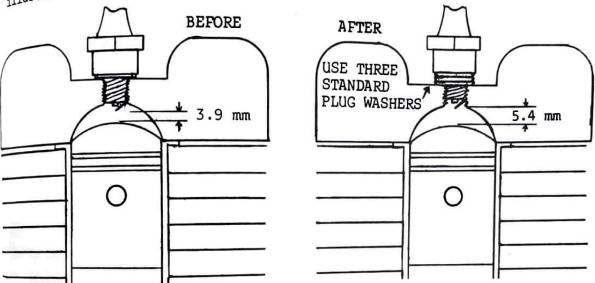
Overheating problems may occur on any YL-2 with an engine number earlier than 4,328. This problem, caused by the spark plug being located too close to the piston dome, may be cured by adding two (2) extra sparkplug washers for a total of three. The drawings below illustrate the modification procedure.

Another solution is to use a short reach plug such as the ones listed below:

NGK -- B8C AC -- 42, C42-1, 401 CHAMPION -- H03, J4J

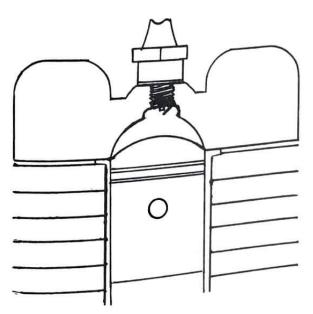
This problem has been corrected on all YL-2s with engine numbers later than 4,328 by using slightly different shaped heads, as shown in the drawing below. After Engine Number 4,328 use a standard B8HC spark plug.
