## MEASURE REPORT

REF. No. MC-88049

MODEL	TDR240/250, TZR250	FILE	
SUBJECT	PISTON MELTING AT CROWN	<a href="http://www.legends-yamaha-enduros.com">www.legends-yamaha-enduros.com</a>

MODEL	TZR250 '87, '88	<a href="http://www.legends-yamaha-enduros.com">www.legends-yamaha-enduros.com</a>	FILE	
SUBJECT	PISTON SEIZURE

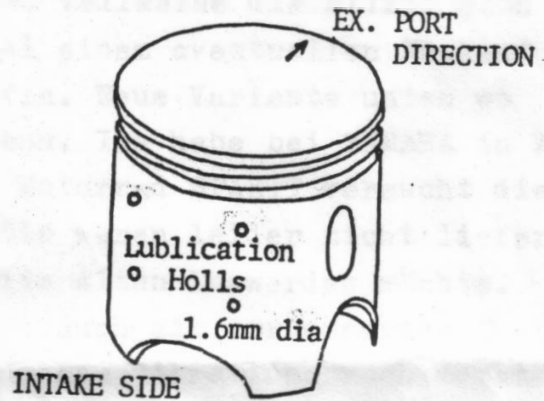
Market report indicate knocking engine noise and piston seizure.

At the early break-in of an units, some units may be experienced scuffing between piston and cylinder wall insufficient lubrication. Then scuffing caused to piston seizure.

To prevent scuffing at early break-in, we are going to change the piston design as simlure with 2YK type (TDR250) as a next model. The 2YK type piston has four location of lubrication holls at intake side as shoun in the left. These holls will provide greater lubrication effect between piston and cylinder wall comparison with present ones.

If you encounter a smilure problem, please recommend your dealer to use following part instead of STD ones. Recommended piston is as same as TDR250 model's one.

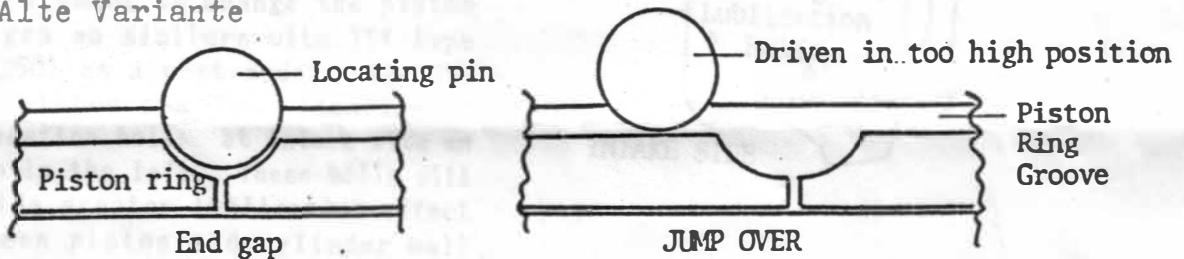
Alte Variante

Market report indicates that the a piston ring is broken catching with cylinder port.

The piston ring located pin may be experienced driving into piston ring groove with insufficient dimension accuracy in some units ( drivig upward comparison with specified location ) . And also locating pin can be worn. These matter may cause that piston ring end gap can jump over the locating pin and then end gap will catch with cylinder ports. See below.

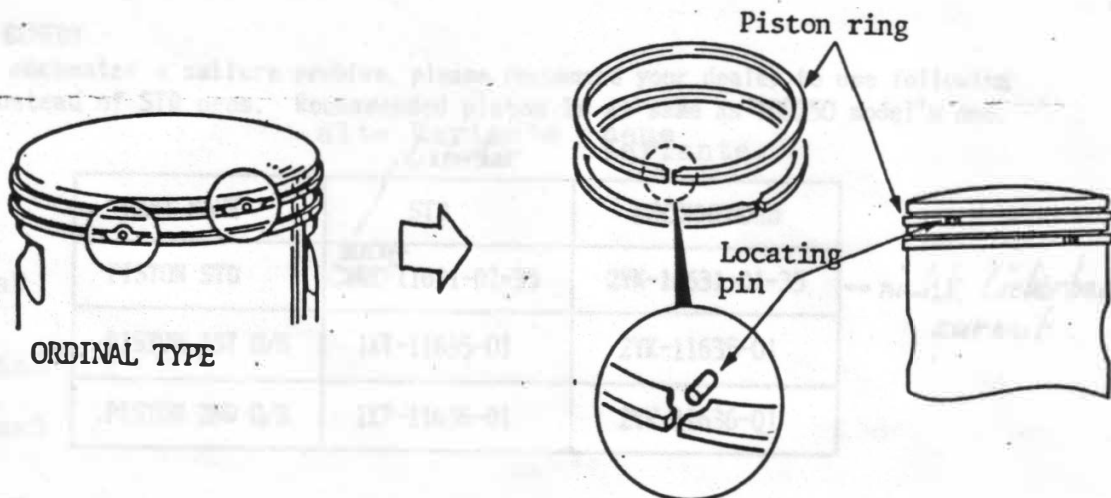
neue Variante

YZ TYPE LOCATING PIN

To prevent jumping over, locating method of piston ring will be changed to YZ type as shown in below. Now we are investigating this remedy to employ with next model.
